**2015 NDIA GROUND VEHICLE SYSTEMS ENGINEERING AND TECHNOLOGY SYMPOSIUM
MODELING & SIMULATION, TESTING AND VALIDATION (MSTV) TECHNICAL SESSION
AUGUST 4-6, 2015 – NOVI, MICHIGAN**

INTERIOR HEAD IMPACT PROTECTIVE COMPONENTS AND MATERIALS FOR USE IN US ARMY VEHICLES

**Julie Klima
Rebecca Marquardt**
Ground Systems Survivability
TARDEC
Warren, MI

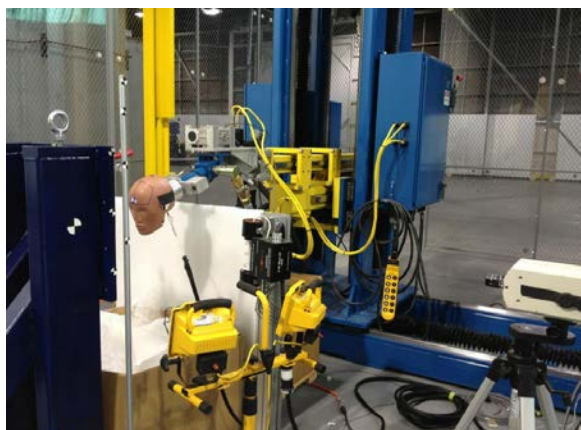
TARDEC utilized the Soldier System Interface Impactor Laboratory located at Selfridge Air National Guard Base, Harrison Township, Michigan (SANG SSII) to conduct head impact testing, Figure 1. The SANG SSII is equipped with head impact test equipment consistent with the FMVSS 201U standard using a Free Motion Headform.

Figure 1: Head impact fixture

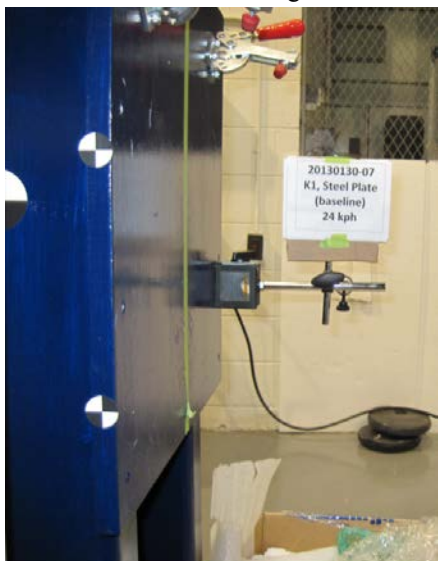
TARDEC tested different COTS energy attenuating (EA) core materials at the SANG SSII laboratory using a rigid flat fixture, Figure 2. The core material requires an additional layer of protection for durability. The additional durable layer of material is referred to by TARDEC as an exposed surface sheet. Each core material was tested with a different durable exposed surface sheet to understand the effects the exposed surface sheet had on the energy attenuation characterizes of the core materials.

**Figure 2:** Rigid Flat Fixture

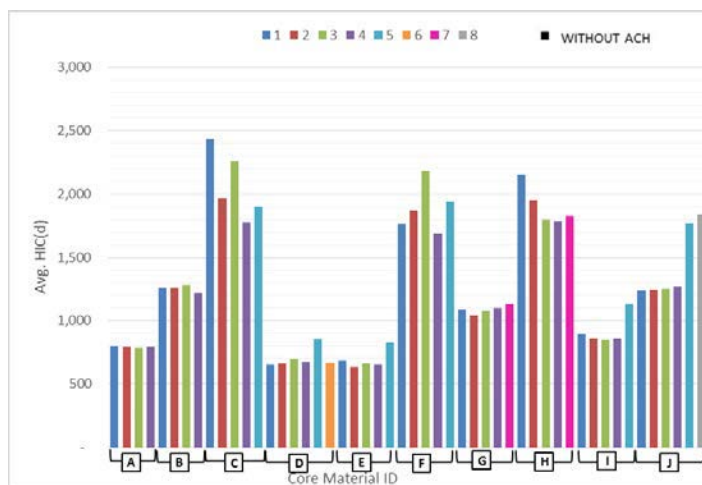
The material samples with fabric exposed surface sheets generally performed better than the hard exposed surface sheet samples, facesheet material IDs 1 through 4, 6, and 7. Figure 6 shows the data from the flat fixture testing. The thicker core materials with fabric based surface sheets, core material IDs D and E, performed below HIC(d) ≤ 1000 requirement at HIC(d) 636 to 855 for the 38 mm (1.5 inch)

thick TPE engineered core material and HIC(d) of 847 to 1131 with the 41 mm (1.6 inch) thick aluminum non-resilient core material, core material ID I. The foam covered in fabric in 25.4 mm (1 inch) thick samples covered in fabric, core material ID G, also showed results around the HIC(d) threshold at HIC(d) 1088. None of the thinner samples tested performed below the HIC(d) requirement, core material IDs B, C, F, H and J. The lowest HIC(d) value of the thinner samples was HIC(d) of 1254 which is a resilient plastic core material covered in fabric, core material ID B. The thin material samples, core material IDs B, C, F, H, and J, with hard surface sheets, facesheet material ID 5 and 8, showed significantly higher test results with the lowest HIC(d) value of 1768.

Figure 6: Material AoA HIC(d)

One of the TPE engineered materials, core material ID A, test results showed an average HIC (d) of 792 at a thickness of 35.56 millimeters (1.4 inches). A non-resilient material, core material ID I and J, (does not retain fit and form after impact) such as aluminum formed in a tubular shape, also uses air-space for enhanced energy attenuation. The 40mm (1.6 inch) thick non-resilient material, core material ID I, resulted in an average HIC(d) of 919.

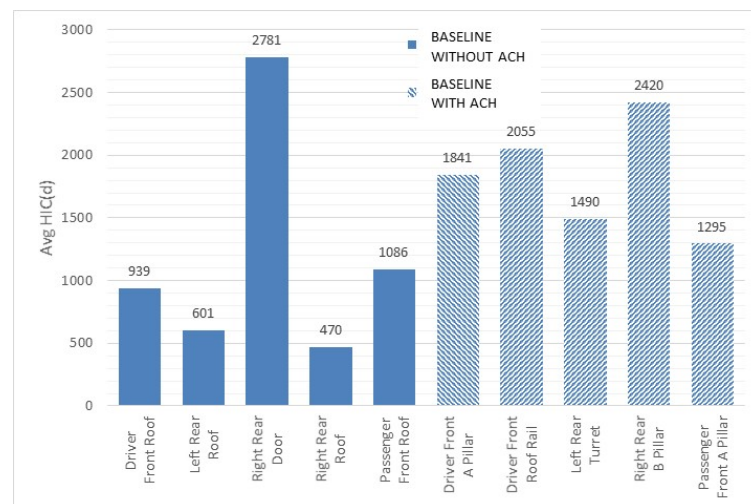
Vehicle baseline testing was conducted using the head impact laboratory facility at SANG. In order to quantify the injury reduction due to the introduction of the IIPS, baseline testing was conducted with and without an ACH affixed to the FMH. The baseline testing data of vehicle A can be seen in Figure 7.

The baseline testing at the driver front roof, left rear roof, and right rear roof were within the threshold requirement of HIC(d). The driver front roof impact position without an ACH has HIC(d) of 939. The HIC(d) for the left rear roof target

The baseline testing at the following locations exceed the injury criteria: right rear door, passenger front roof, driver front a-pillar, driver front roof rail, left rear turret, right rear b-pillar, passenger front a-pillar. The HIC(d) for the driver front a-pillar location with an ACH was on average 1,841. The driver front roof rail with an ACH had an average HIC(d) of 2,055. The HIC(d) for the a-pillar with ACH target location had a HIC(d) of 1,294. The roof target location without an ACH had an average HIC(d) of 1,086. The turret location with an ACH had an average HIC(d) of 1,489. The HIC(d) for the b-pillar location with an ACH was on average 2,420. The door location without an ACH had an average HIC(d) of 2,781.

Figure 7: Vehicle A HIC(d)

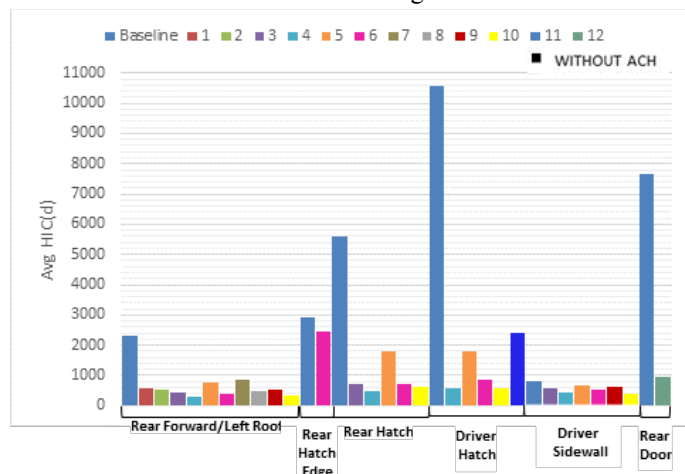
The vehicle B has a very rigid interior design, testing for the vehicle was conducted without the helmet on the FMH, to improve test repeatability. Figure 8 shows the data from vehicle baseline testing at head impact test locations: driver hatch, driver sidewall, rear passenger roof and the rear hatch.

All of the locations that were baseline tested with the exception of the driver sidewall, far exceeded the performance criteria of HIC(d) ≤ 1000 . The driver hatch showed the highest test results at HIC(d) 10,556.8. The rear hatch also showed high test results at HIC(d) 5596.0 and the rear passenger roof results were HIC(d) 2308.5.

Figure 8: Vehicle B HIC(d)

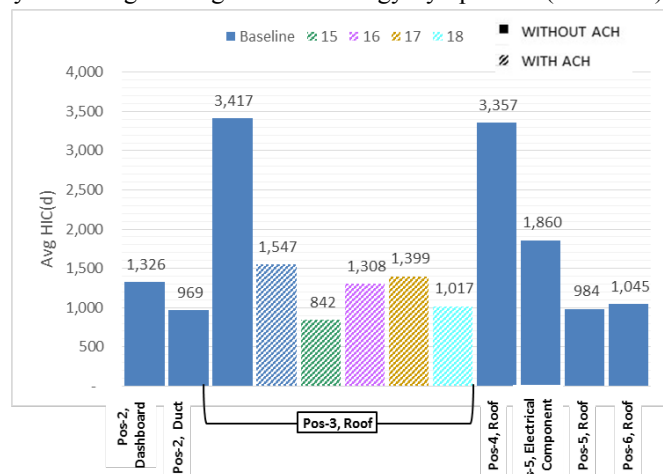
Figure 9 shows Vehicle C baseline testing data. Baseline testing without an ACH at the following locations exceed the injury threshold requirement: Pos-2 dashboard, Pos-3 roof, Pos-4 roof, Pos-5 electrical component, and Pos-6 roof. Pos-2 duct and Pos-5 roof did meet the threshold requirement for baseline testing with a HIC(d) of 969 and 984 respectively.

Further head impact testing was conducted on Pos-3 roof, which had a baseline HIC(d) of 3,417. Baseline testing as repeated with the addition of an ACH, the resulting HIC(d) was 1,547. Four EA materials were impact tested at this position. One of the four EA materials tested met the threshold requirement with a HIC(d) of 842.

Figure 9: Vehicle C HIC(d)

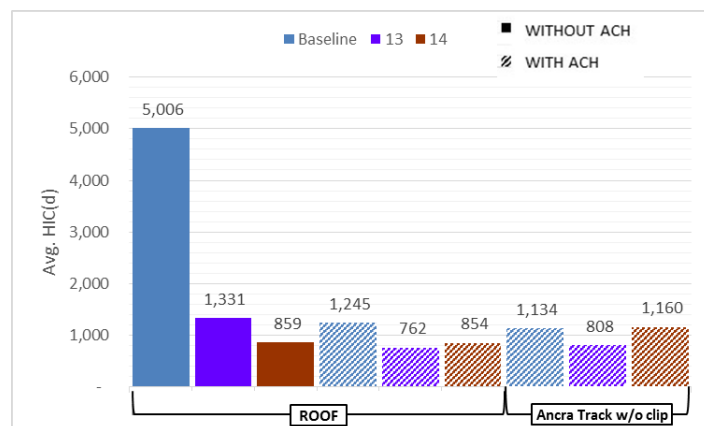
Baseline testing was conducted in the two target locations in trim buck: roof and Ancra track without clip. The Ancra track clip's function is to secure basic issue items, bii. The baseline testing on the roof was conducted with and without an ACH. This baseline testing exceeded the injury threshold criteria with an HIC(d) of 1,245 and 5,006 respectively. Ancra track baseline testing was not conducted without a helmet due to the probability of damage to the FMH skin. The design intent of Trim Buck is to have the Ancra track located out of the head impact zone. Baseline testing on the Ancra track was conducted with an ACH and resulted in a HIC(d) of 1,134, which exceeded the injury threshold requirement. The data from this testing can be seen in Figure 10.

Figure 10: Trim Buck HIC(d)

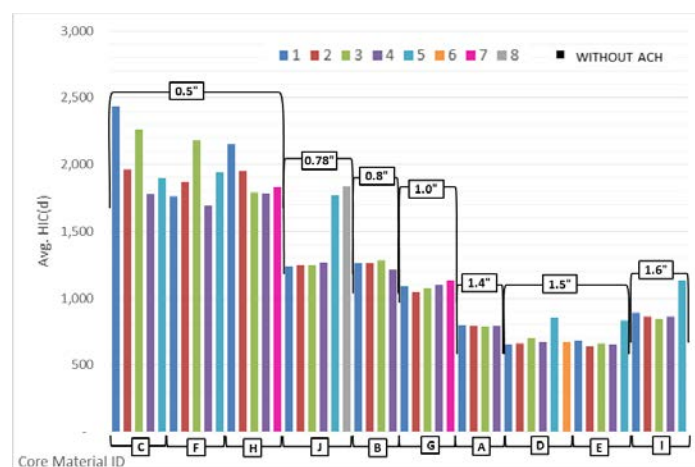
Core material thickness appears to be the main characteristic affecting HIC(d) energy attenuating performance independent of the type of surface sheet material or attachment method as seen in Figure 11. The thicker core materials performed better than the thinner core materials. The average peak value of HIC(d) for the materials with a thickness of 12.7 mm (0.5 inch) is 1,953. The materials with a thickness of 25.4 mm (1 inch) has an average peak value of HIC(d) equal to 1,088. As the core material increases its thickness to 38.1 mm (1.5 inch) the average peak HIC(d) value continues to decrease to 693, supporting the observation that a thicker material reduces the head impact criterion. Looking at the materials with a thickness of 25.4 mm (1 inch) and less have an average peak HIC(d) value of 1,612. Whereas materials with a thickness of greater than 25.4 mm (1 inch) has an average peak HIC(d) value of 772. The material thickness threshold for achieving the head injury criteria is greater than 25.4 mm (1 inch).

Figure 11: AoA Flat Fixture Material Thickness

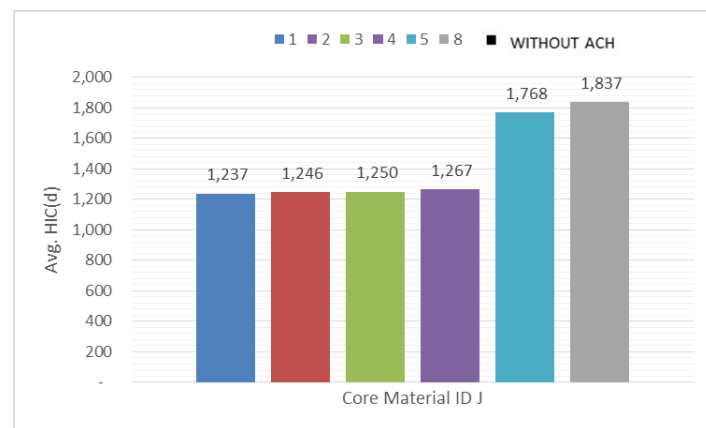
Only some of the fabric based surface sheet samples with the low profile core material thickness, performed below the threshold HIC(d) < 1000 requirement and only one of the hard surface sheet samples with low profile core materials achieved the threshold requirement. These observations indicate the low profile core materials are more sensitive to the type of surface sheet material used, than the high profile, thicker core materials. AoA Test Material Matrix shows that facesheet material IDs 1 through 4, 6, and 7 are fabric and facesheet material IDs 5 and 8 are rigid. Figure 12 shows core material ID J with a thickness 19.8 mm (0.78 inch) and how the fabric and rigid face sheets directly affect the core material's response to the injury criteria. The rigid face sheet increases the HIC(d) by an average of 553.

Figure 12: Core Material ID J, 19.8 mm (0.78 inch) thickness

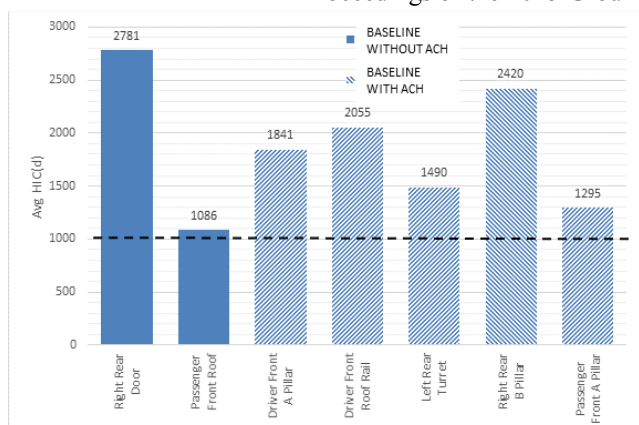
As shown in the Figure 13, the average HIC (d) for baseline testing on Vehicle A shows that the vehicle exceeds the threshold requirement for HIC (d) of equal to or less than 1,000 on the impact positions associated with the right rear door and passenger front roof without an ACH and driver front a-pillar, driver front roof rail, left rear turret, right rear b-pillar, passenger front a-pillar with an ACH.

Figure 13: Vehicle A Positions that Exceeds Threshold

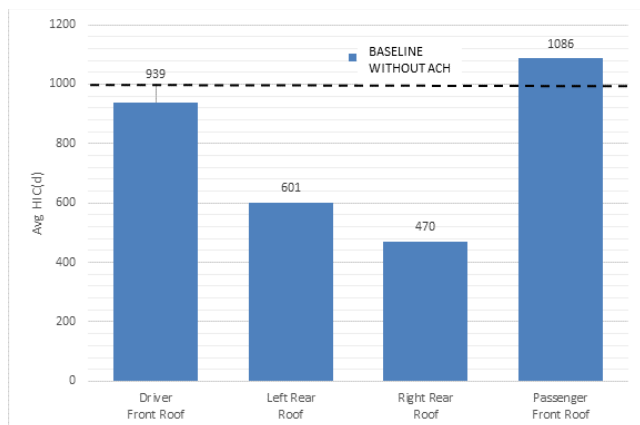
The baseline testing on the roof location testing was conducted without an ACH, Figure 14. In three of the four roof locations tested the head injury criterion was below the threshold and in two of three locations was also below the objective. The passenger front roof location had an average HIC(d) of 1,086.4 without an ACH. Previous testing has indicated that the ACH can reduce HIC(d) by 100 to 300. There is confidence that with an ACH the HIC(d) would be below the threshold requirement.

Figure 14: Vehicle A Roof Position Head Impact Testing

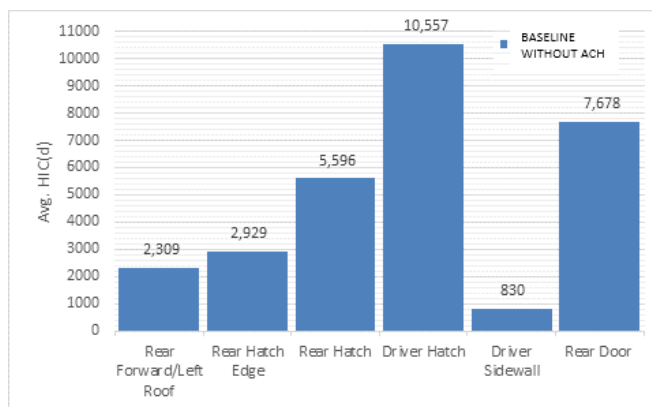
Figure 15 shows the HIC(d) test results of the vehicle baseline without energy attenuating materials and the HIC(d) test results with the material samples. The baseline HIC(d)

results are significantly higher than the injury criteria requirements ($HIC(d) < 1000$) with the exception of the driver sidewall location. The driver sidewall location consists of an electrical door panel which may act as an energy attenuator providing enough energy dissipation to prevent impact related head injuries without needed additional protection.

Figure 15: Vehicle B Baseline Head Impact Testing

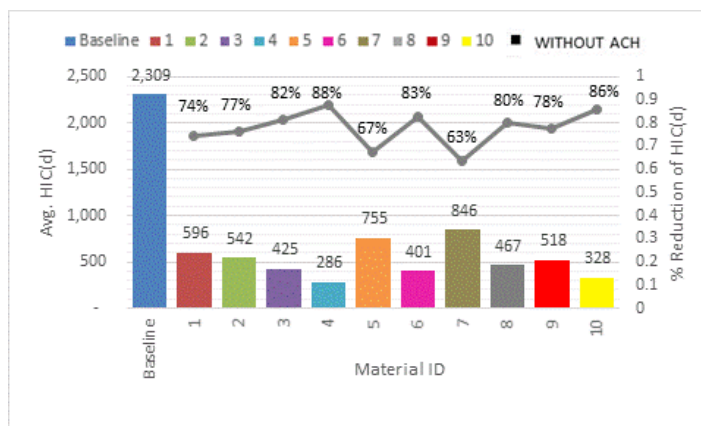
IIPS solutions were testing at the rear forward/left roof position. Material IDs 1 through 10 were impacted to evaluate the influence EA materials have on HIC(d). Figure 16 shows the percent reduction and average HIC(d) values. All ten material ID solutions proposed met the injury threshold requirement for HIC(d) and had a significant percent reduction over the baseline testing ranging from 63% to 88% reduction.

Figure 16: Rear Forward/Left Roof HIC(d) and Percent Reduction

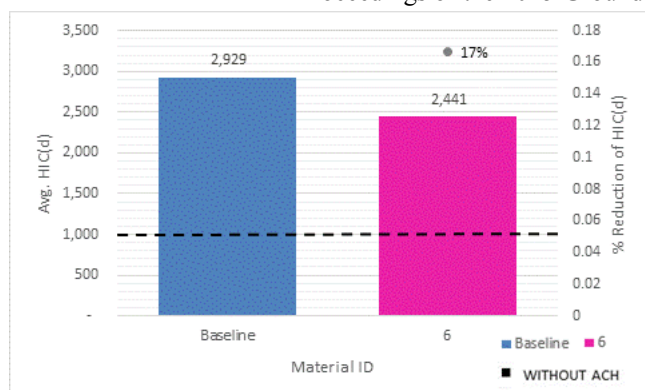
Material ID 6 was tested at the rear hatch edge position in Vehicle B, Figure 17. Material ID 6 improved the performance of HIC(d) by 17%, but still exceeded the injury threshold requirement. Additional material ID testing at this location needs to occur.

Figure 17: Rear Hatch Edge HIC(d) and Percent Reduction

Material ID 6 resilient foam material was the only material tested at the rear hatch edge location because of its capability to form around complex edge surfaces. The first impact of the free motion head form on the rear hatch edge covered with Material ID 6 was aborted because the edge cut through the material cutting the skin on the free motion head form. To date, edge protection solutions still need to be addressed.

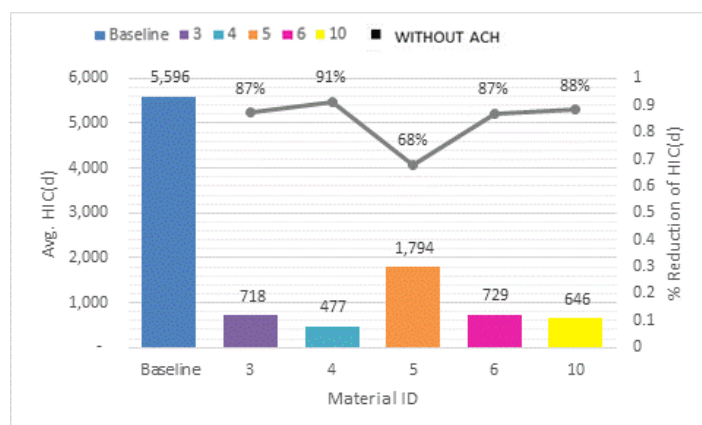
The rear hatch vehicle position was tested with material IDs 3, 4, 5, 6, and 10 to see if reduction of baseline would occur, Figure 18. Material IDs 3, 4, 6, and 10 meet the injury threshold criteria. Material ID 5 exceeded the injury threshold criteria and is not a viable solution. However each material ID provided significant percent reduction over baseline HIC(d) ranging from 68% to 91% reduction.

Figure 18: Rear Hatch HIC(d) and Percent Reduction

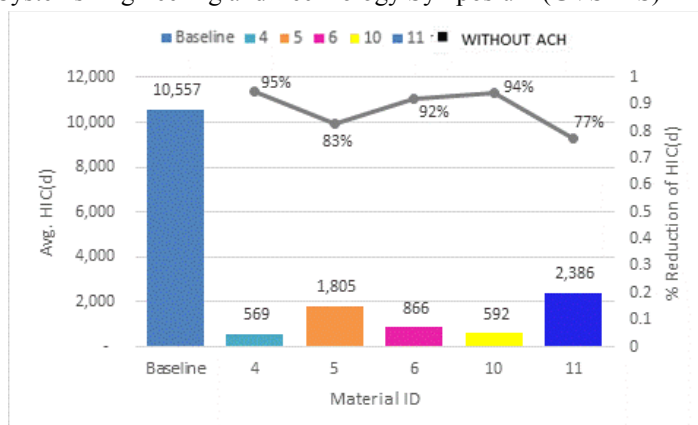
The driver hatch position had a baseline HIC(d) of 10,557, which exceeds the injury threshold criteria. Material ID solutions 4, 5, 6, 10, and 11 were tested to see if viable solutions to achieve the threshold injury criteria. The results can be seen in Figure 19. The material IDs showed a 77% to 95% reduction of HIC(d) over baseline testing. Material IDs 4, 6, and 10 are solutions for the driver hatch position to meet the injury threshold criteria.

Figure 19: Driver Hatch HIC(d) and Percent Reduction

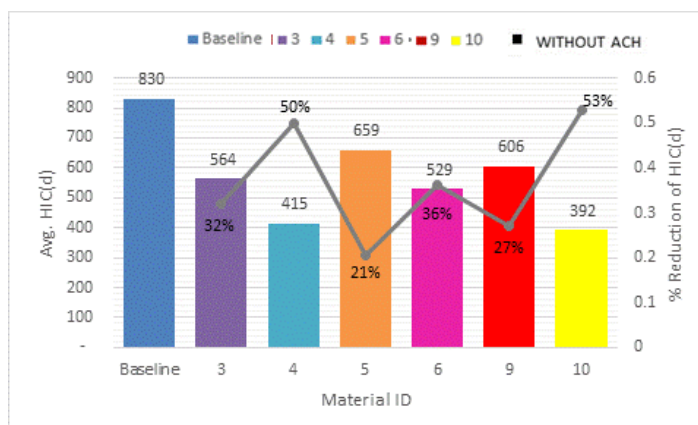
The driver sidewall position baseline HIC(d) value is 830. This position meets the injury threshold criteria, however material ID solutions were tested at this position, Figure 20. There was a reduction in HIC(d) from 27% to 53%, all material solutions are viable options to continually reduce the head injury criteria.

Figure 20: Driver Sidewall HIC(d) and Percent Reduction

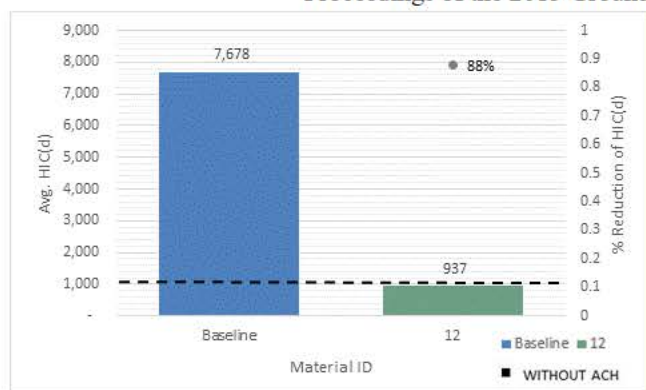
The rear door position was impact tested using material ID 12, Figure 21. The HIC(d) value during baseline testing was 7,678 and the IIPS solution reduced the value by 88%. The rear door position with material ID 12 meets the injury threshold value and is a solution at this location.

Figure 21: Rear Door HIC(d) and Percent Reduction

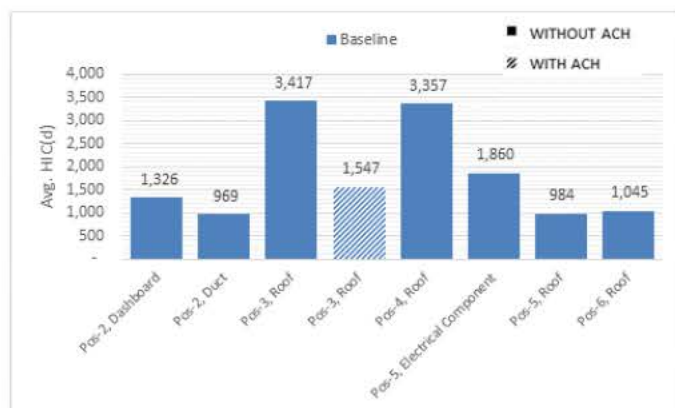
As shown in the Figure 22, the average HIC (d) for baseline testing on Vehicle C without and ACH shows that the vehicle exceeds the threshold requirement for HIC (d) at the impact positions associated with position two: dash board, position 3: roof, position 4: roof, and position 5: electrical component, roof. Pos-2 duct and Pos-5 roof did meet the injury threshold requirement during baseline testing without an ACH. IIPS are needed at the locations that exceeded the injury threshold.

Figure 22: Vehicle C Baseline HIC(d)

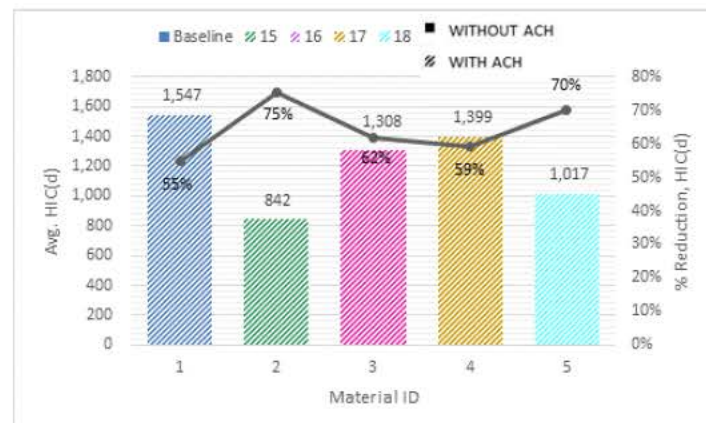
Figure 23 shows percent reduction and the average HIC(d) for the additional head impact testing was conducted on Pos-3 roof. Pos-3 roof baseline testing was conducted with an ACH, which yielded a 55% reduction over baseline without an ACH. Material IDs 15 through 18 were then tested with an ACH on impact location Pos-3 roof. Material ID 15 met the injury threshold requirement with a HIC(d) of 842. Material IDs 16 through 18 exceeded the injury threshold requirement with an average HIC(d) of 1,308, 1,399, and 1,017 respectively. All materials ID solutions had a significant percent reduction in HIC(d) from the baseline without ACH testing ranging from 59% to 75% reduction. Material ID 15 is

the only viable solution tested that could be utilized in Pos-3 roof to meet the threshold requirements.

Figure 23: Pos-3 Avg. HIC(d) and Percent Reduction

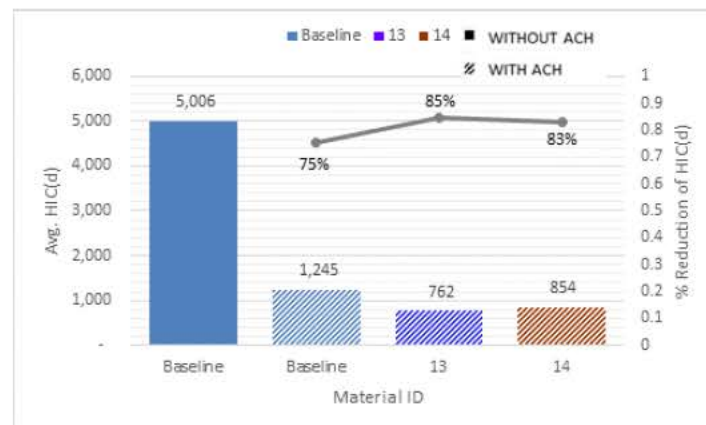
The HIC (d) for baseline testing on the roof location with and without an ACH shows that the introduction of a helmet greatly reduces HIC (d). The introduction of an ACH into the baseline testing produces a 75% reduction over the baseline testing without an ACH. The use of Material ID 13 with an ACH has an 85% reduction over the baseline testing without an ACH. The minimal crush pattern on the Material ID 13 core material show that the Material ID 13 exposed surface sheet absorbs significant amounts of energy during impact. Material ID 14 with an ACH reduced the value of HIC(d) by 83% over the baseline testing without ACH. Figure 24 illustrates the reduction an ACH and the introduction of EA material solutions have on reducing the injury criteria to meet the threshold requirement.

Figure 24: Roof HIC(d) and Percent Reduction

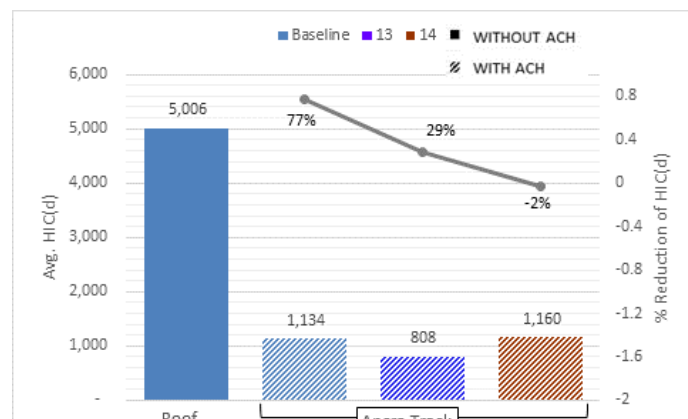
Figure 25 shows the Ancra track testing head injury criteria results. The baseline testing on the Ancra track conducted

with an ACH show a 77% reduction in head injury criterion from the roof baseline testing without a helmet. Material ID 13 with an ACH has a 29% reduction in the head injury criteria over the baseline Ancra track testing with an ACH. The HIC(d) of material ID 13 with an ACH at the Ancra track is 808 meeting the injury threshold requirement.

Figure 25: Ancra Track HIC(d) and Percent Reduction

Material ID 14 had a -2% reduction, Figure 25, over the baseline Ancra track testing with an ACH. This was the result of the core material not being fully engaged on the Ancra track. The backing of material ID 14 was reinforced with steel, this resulted in the core material being too rigid and simulated testing equivalent to the stand alone fixture. In the second test of the material ID 14 with ACH Ancra track series, the FMH impacted the steel reinforcement through the IIPS resulting in a HIC(d) of 1,435. This result is greater than the average HIC(d) of the Ancra track baseline testing. The properties of the Material ID 14 core material and the ability to absorb energy are affected by the addition of the steel backing. A different attachment method needs to be developed to keep form while using a non-formed exposed surface sheet.
